BPG Inspection, LLC

**581 Berkeley Avenue
Menlo Park CA 94025**

Inspection Date: 8/12/2024

Inspector: Tyson Durm , ASHI # 265210 (CA)

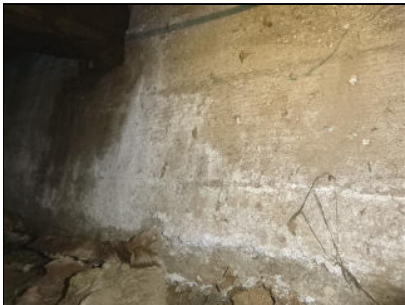
- ◆ The foundation appears to have performed well and was in generally serviceable condition, except as noted. Some hairline cracking and/or surface spalling was observed. These conditions are typically the result shrinkage of materials and/or minor settlement.
- ◆ NOTE: There was a white, powdery material observed on portions of the concrete foundation and/or piers. This is known as efflorescence, and it occurs as a result of moisture being absorbed into the foundation, and then evaporating out if it. This condition can cause surface deterioration, or "spalling" of the surfaces, however it is generally a cosmetic consideration. Efflorescence typically occurs when excessive water collects at the foundation, and we recommend attention to grading and drainage to minimize future efflorescence, and to maximize service life.

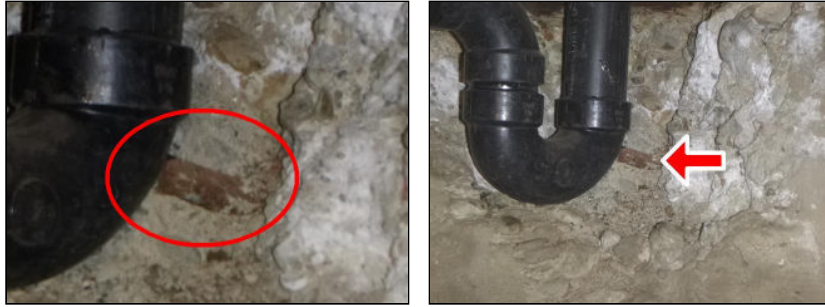
- ✗ ◆ We observed exposed rebar visible within the concrete foundation at the left side, under the left side hall bathroom, as seen from the crawl space, where it appears the stemwall had been cut to accommodate the tub drain. We recommend that the exposed rebar be wire brushed, primed and sealed to prevent corrosion, expansion and subsequent damage to the concrete foundation.

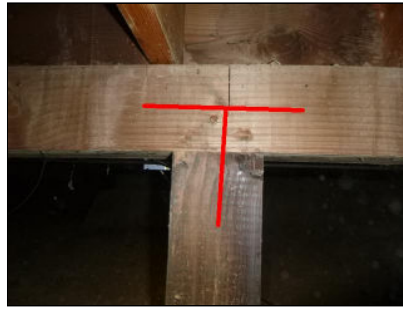
- ◆ Anchor bolts were observed in the foundation, however the type, size and spacing of the bolts does not meet current standards. No particular deficiencies were noted, however we recommend that upgrading be considered. If more information is desired, we recommend referral with a seismic specialist or general contractor.
- ◆ The pier and beam connections in the crawl space were only marginally secure. We recommend that additional "T" straps be installed for improved structural integrity in the event of an earthquake.

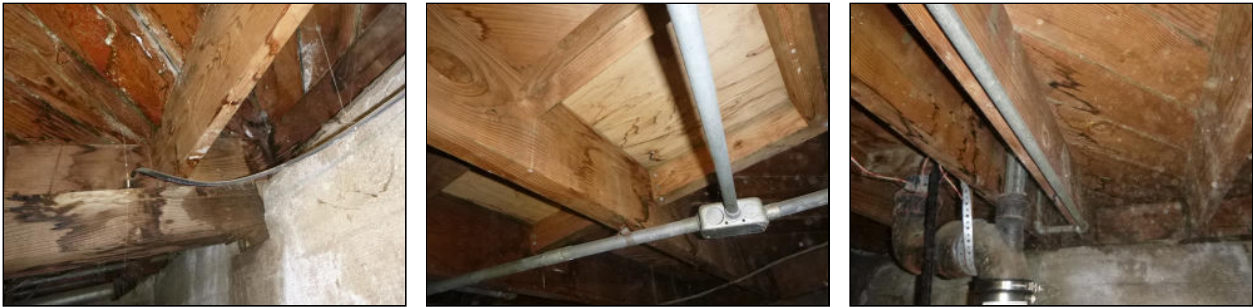
- ◆ Water stains were observed on the subflooring and framing under the kitchen and bathrooms, as seen from the crawl space. The area was dry at the time of this inspection, and no deterioration was evident. We recommend periodic inspection, and review of a current structural pest control report for possible comments.

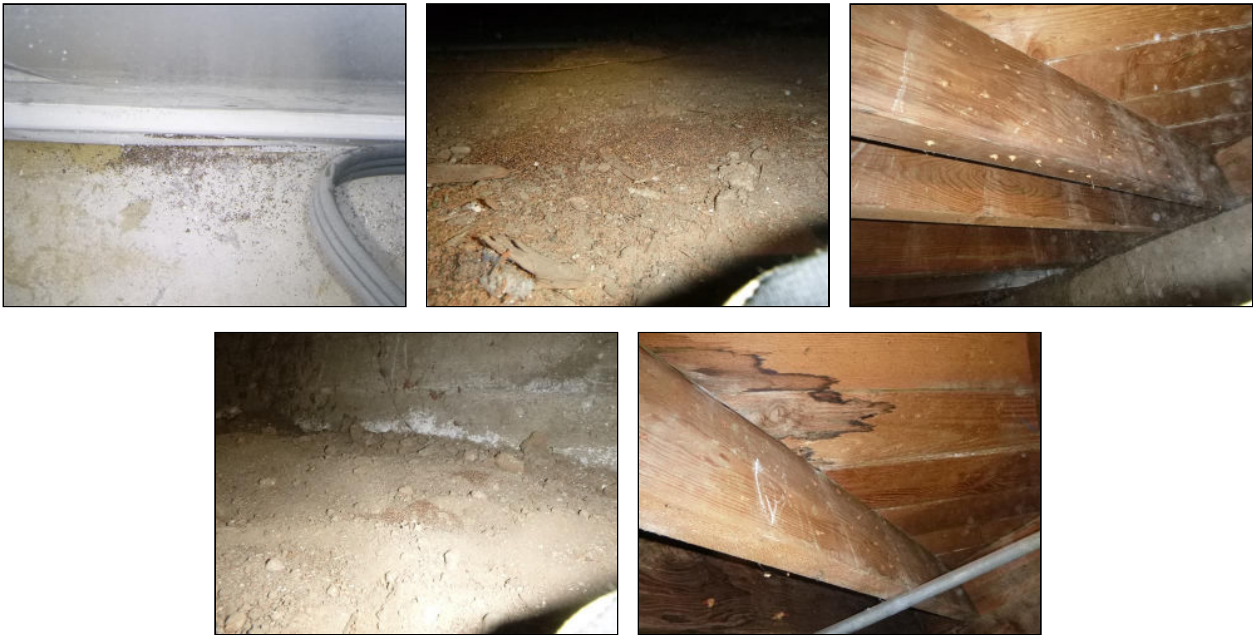
- ⊠ ♦ We observed evidence of wood-destroying organism activity in the laundry room, behind the appliances, as well as at the floor joists and subfloor in the crawlspace below the laundry room. We recommend review of a current structural pest inspection report for additional comments and recommendations and replacement of all damaged material by a qualified, licensed contractor.

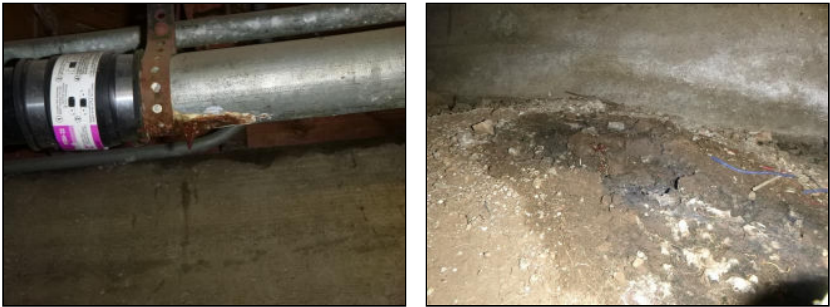
- ⊠ ♦ We observed heavy corrosion and minor leakage through the galvanized steel drain piping under the kitchen, as seen from the crawl space. We recommend further review by a licensed plumber or general contractor, and repair or replacement of all damaged piping as recommended.

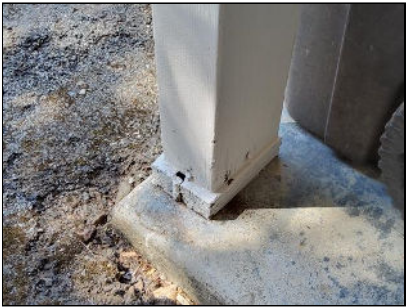
- ✗ ◆ Deterioration was observed in the base of the support post at the left rear corner. We recommend review of a current structural pest inspection report for more information and recommendations and replacement of all damaged material by a qualified, licensed contractor.

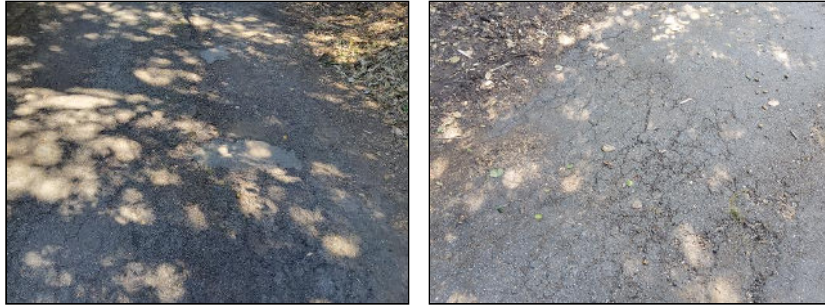
- ⚠ ◆ The asphalt driveway has cracked, deteriorated and/or settled to the point where resurfacing or replacement is called for. We recommend referral with an asphalt specialist for more information and recommendations.

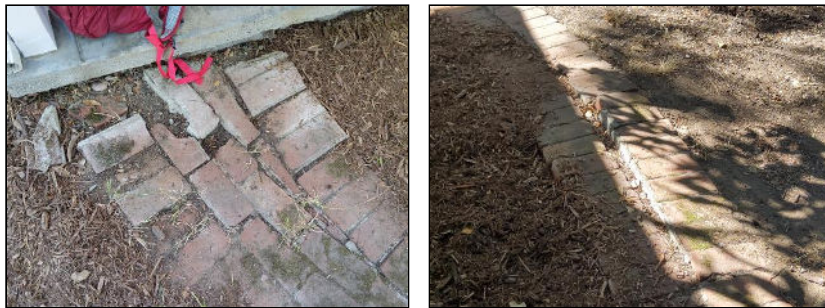
- ◆ There was cracking and settlement observed in sections of the brick walkways at the right side. We recommend patching or repair for improved appearance and safety.

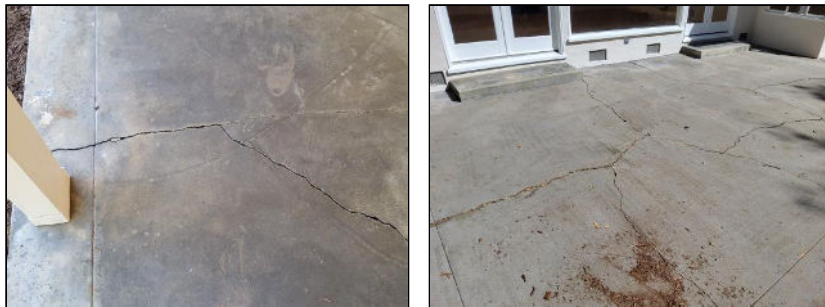
- ◆ Small to moderate cracks were observed in the concrete porch and patio surfaces. We recommend patching or repair for improved appearance and to minimize water penetration and further damage.

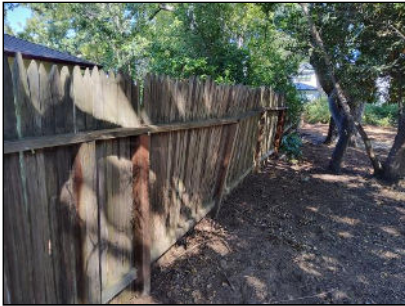
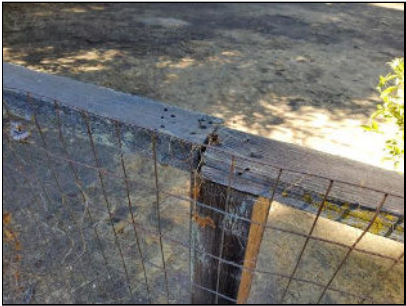
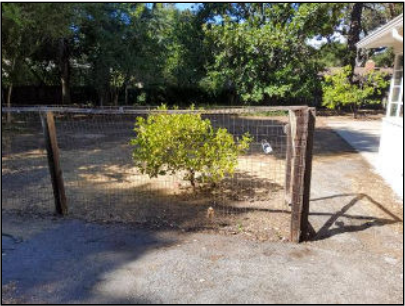
♦ Sections of the fencing at the right side and rear were damaged, loose and leaning. We recommend that the fences be resupported, repaired or replaced as necessary.

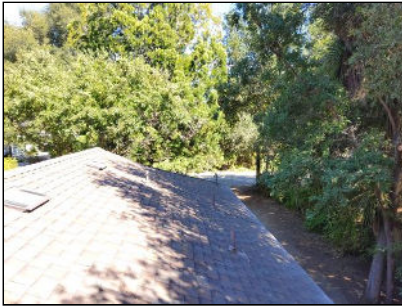
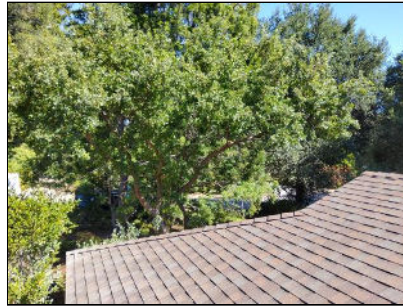
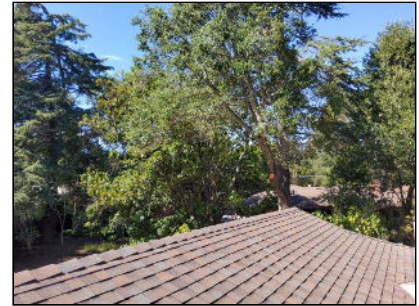
- ⚡ We observed tree branches growing over the roof surface in some areas. We recommend that they be trimmed back to help prevent roof damage from contact with the branches.

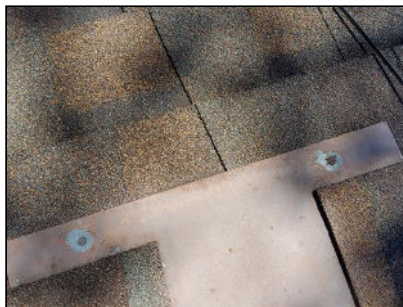
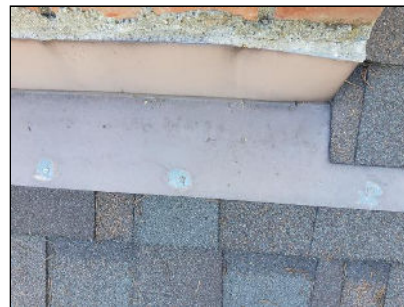
- ⚡ NOTE: The mastic (tar) flashings at the rooftop penetrations are prone to expansion and contraction, drying and cracking. We recommend they be periodically inspected and sealed as necessary.
- ⚡ The nails or metal fasteners used to secure some flashings are exposed and unsealed, creating the opportunity for leakage. We recommend all exposed fasteners be sealed with caulking or roofing mastic.

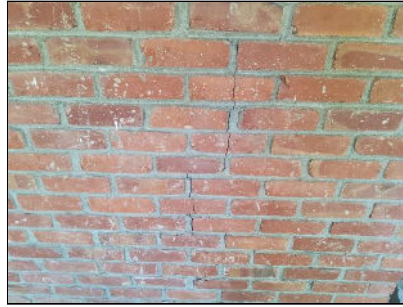
- ⚡ Chimneys are a common source of water infiltration, both at the roof and inside the structure. Maintaining the flashings and a proper weather cap will reduce the chances of a problem. Portions of the flashing and interior of the chimney are not visible during our inspection. The NFPA recommends having what is called a Level II inspection by a qualified chimney sweep, to include a camera scan of the interior of the chimney. A Level II inspection can identify problems not noted in our report. You can find a list of certified sweeps at www.csia.org
- ⚡ We observed small to moderate cracks in the bricks and mortar at the back/base of the chimney. We recommend they be sealed, patched or repaired for a better appearance and to help prevent moisture penetration and further damage.

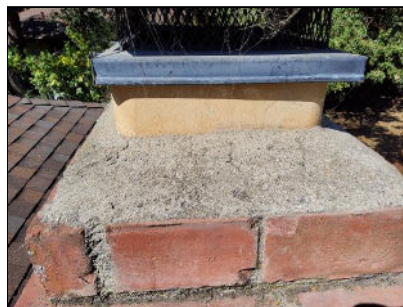
- ✎ ◆ The mortar cap at the top of the chimney (also known as the crown wash) was cracked, eroded and/or poorly sealed. This is a common condition, but can lead to moisture penetration and subsequent damage. We recommend that it be resealed by a chimney specialist as a preventative measure.

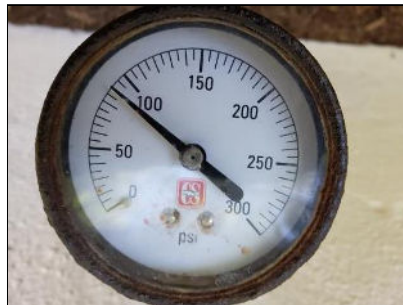
- ☒ ◆ The water pressure, as measured at the exterior hose bibs, was above 80 psi (pounds per square inch), which is considered above the high end of normal. Excessive pressure can result in leakage at the fixtures and/or water supply lines. We recommend further review by a licensed plumber and a pressure reduction valve installed if recommended.

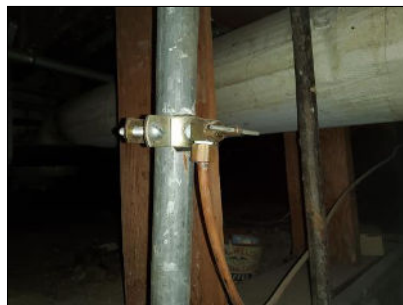
- ☒ ◆ A saddle valve was installed on a water supply line in the crawlspace near the access ladder. These valves are prone to leakage due to their design. While no leakage was noted at the time of inspection, we recommend replacement with a permanently installed valve by a qualified, licensed plumber in order to prevent future leakage.

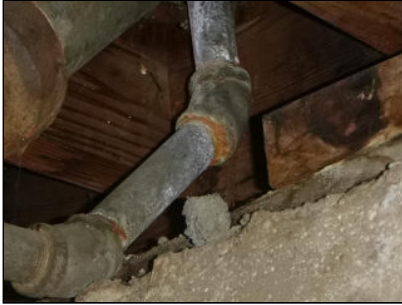
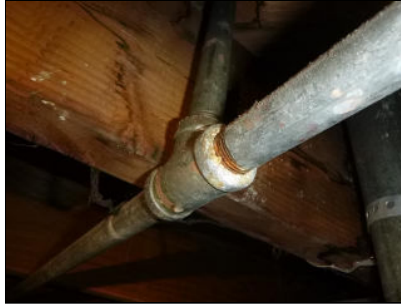
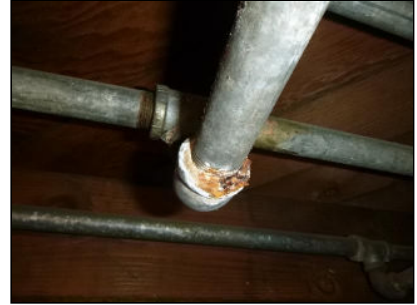
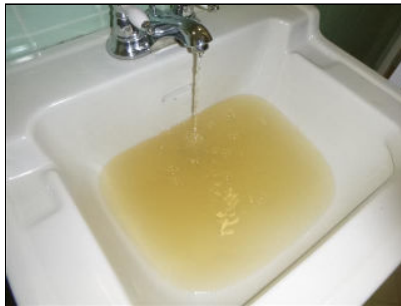
- ☒ ◆ The galvanized steel water supply lines were corroded and the water was rusty or discolored at some of the fixtures. This is usually from mineral deposits building up inside of the older galvanized lines, particularly if fixtures

are not used on a regular basis. This condition is not unusual in older buildings and the water should run clearer when it is run for a few moments, however this is an indication that the pipes are corroding on the inside and replacement should be anticipated and budgeted for.

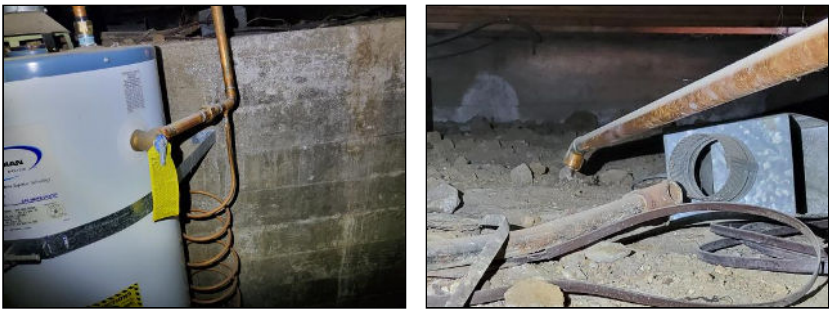
- 🔍 ◆ Because of the location of the water heater, the temperature-pressure relief valve discharge pipe was incorrectly installed, terminated in the subarea and not routed to the exterior as required. We recommend further evaluation by a qualified, licensed plumber or water heater specialist and modification of the discharge pipe or replacement with a gas shut-off valve (Watts 210) if recommended.

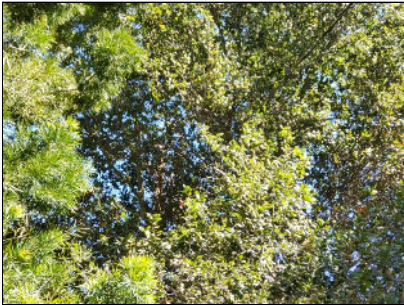
♦ The overhead electrical service wires are in contact with, deflected by tree branches. This could result in damage and/or the interruption of electrical service during high winds. We recommend referral with a tree trimming service and/or PG&E, and the branches trimmed as necessary.

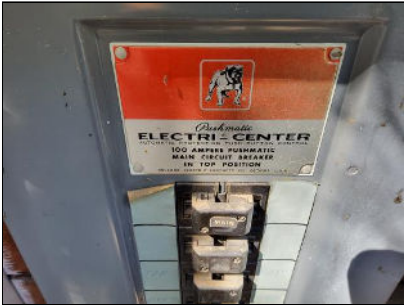
♦ The main electrical service panel was a Bulldog Electric panel with "Pushmatic" circuit breakers. These overcurrent devices require regular maintenance and lubrication to ensure proper, safe function and have a history of failure if not properly maintained. Replacement devices are also difficult to find. Consideration should be given to upgrading the panel to ensure proper, safe function. We recommend further evaluation by a qualified, licensed electrician for upgrade options.

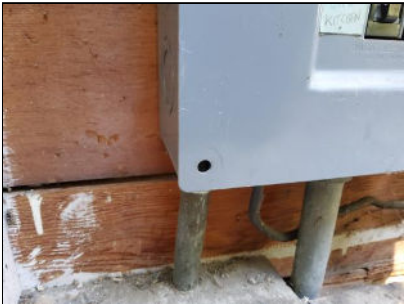
♦ One of the screws was missing from the main electrical panel cover. We recommend replacement with an approved blunt-end screw to prevent movement and for improved safety.

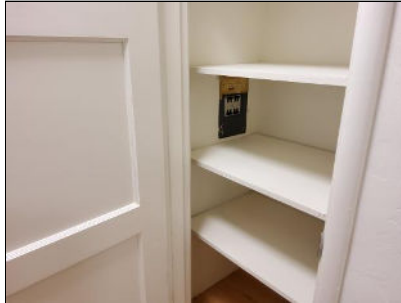
- ◆ NOTE: There is an electrical subpanel located in a closet. This is common finding, however closet installations are no longer approved, and eventual replacement and relocation may be necessary. We only recommend that proper clearance be maintained in front of the panel.

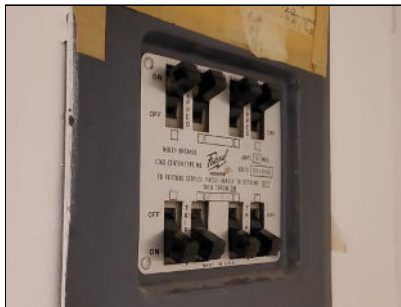
- ◆ The electrical subpanel was manufactured by Federal Pacific Electric. Some of the equipment produced by this company has been associated with product defects, and failure of their overcurrent protection devices (circuit breakers) including rare cases of fires. Although there was no evidence of overheating or failure of the breakers, we cannot predict the likeliness of failure and strongly recommend referral with a licensed electrician for further evaluation, and that replacement of this equipment be considered and anticipated.

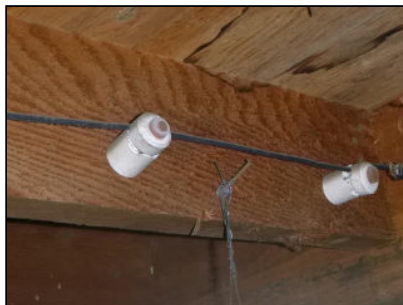
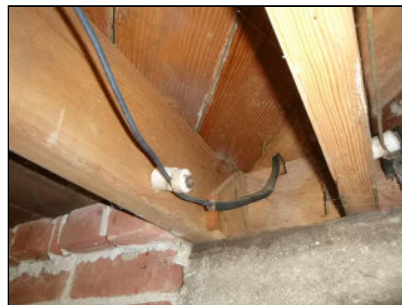
- ◆ Knob and tube wiring is still in use in this building (ceramic knobs and tubes are used to pass wire through and along wood framing components, and act as an insulator). No particular deficiencies were noted, however because of it's age, and the fact that these circuits are ungrounded, we recommend replacement of the knob and tube wiring as upgrades and maintenance projects are undertaken.

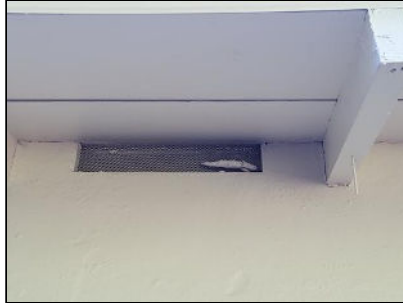
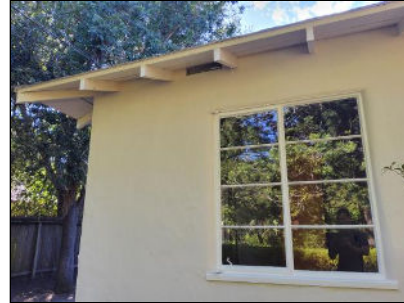
- ✖ ◆ Unprotected and apparently abandoned exterior wiring was observed at the exterior left front at an attic eave vent. We could not verify if this wiring has the possibility of becoming energized. We recommend the wiring be disconnected at it's source or properly terminated inside of a covered junction box by a licensed electrician.

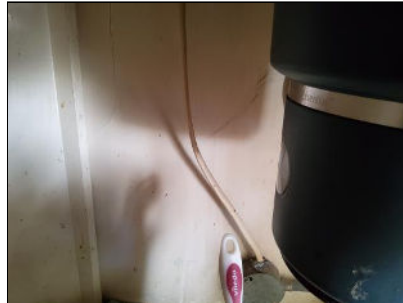
- ✖ ◆ We observed exposed and unprotected electrical wiring (NM - non metallic sheathed cable) in the kitchen sink cabinet. This installation is not approved as the wiring is subject to physical damage. We recommend all unprotected wiring be replaced with "BX" armored cable, "MC" metal clad or physically protected by a qualified, licensed electrician for improved safety.

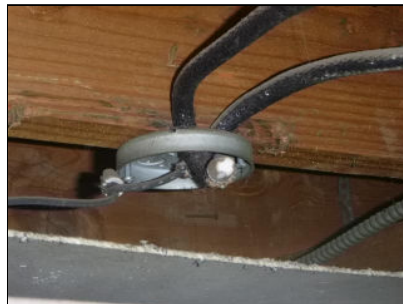
- ✖ ◆ We observed an uncovered electrical junction box in the utility basement, above the water heater. We recommend that it be fitted with an approved cover plate to protect the wiring from accidental contact and physical damage.

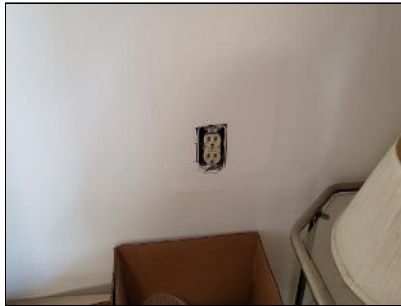
- ✖ ◆ We observed a missing cover plate at one of the receptacles in the right front bedroom closet. We recommend replacement to protect from accidental contact and shock hazards.

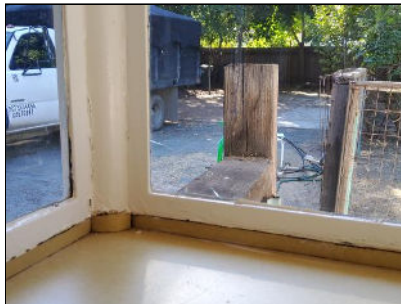
- ◆ We observed cracked glass in one of the kitchen windows. We recommend all cracked glass be replaced by a qualified, licensed contractor for improved safety.

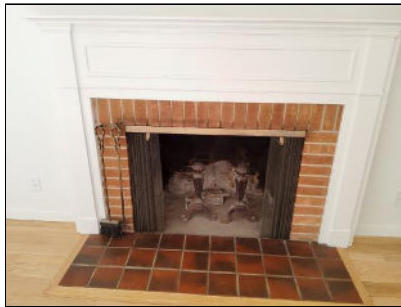
- ✗ The chimney flue was viewed from the firebox, and the visible areas had a buildup of soot and creosote. We recommend referral with the appropriate contractor, and the flue cleaned to ensure safe and proper function.
- ✗ The wooden mantle around the fireplace is too close to the firebox by current standards, and should be considered a potential fire hazard. Although no particular deficiencies were noted at this time, we recommend referral with a fireplace specialist for more information and modification recommendations

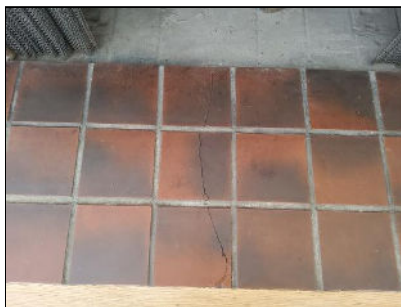
- ✦ The fireplace hearth was cracked and damaged. This is primarily a cosmetic consideration, however we recommend repair or replacement for a better appearance and to ensure the safe use of the fireplace.

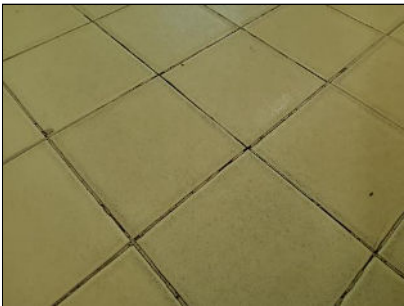
- ◆ There were gaps or voids noted in the grout between some of the floor tiles in the left side hall bathroom. We recommend regrouting and/or caulking to help prevent moisture penetration and subsequent damage.

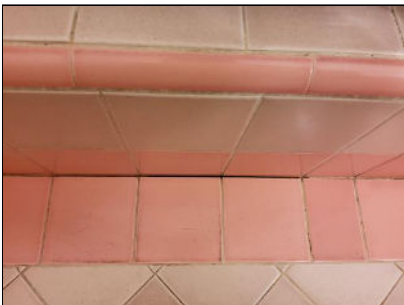
- ◆ The flooring at the base of the right side hall shower was poorly sealed. We recommend that the floor be recaulked to help prevent moisture penetration and subsequent damage.
