BPG Inspection, LLC

**581 Berkeley Avenue
Menlo Park CA 94025**

Inspection Date: 8/12/2024

Inspector: Tyson Durm , ASHI # 265210 (CA)

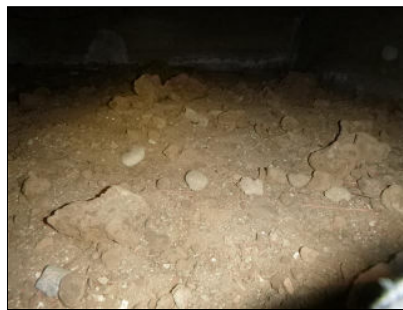
- ◆ Left over construction debris has been left under the building. We recommend all debris be removed for improved access and reduced pest-related activity.

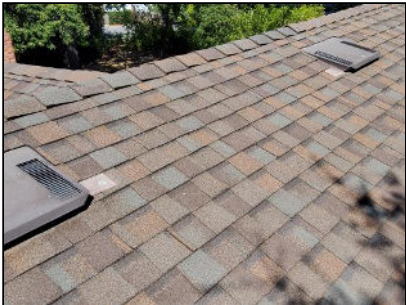
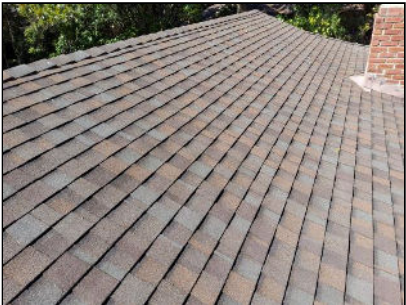
- ⚡ We observed tree branches growing over the roof surface in some areas. We recommend that they be trimmed back to help prevent roof damage from contact with the branches.

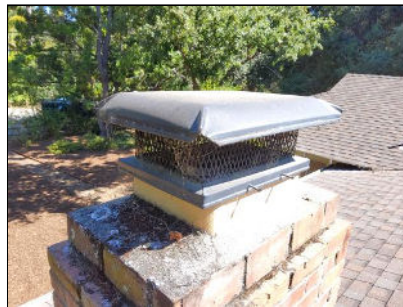
- ✎ ◆ The mortar cap at the top of the chimney (also known as the crown wash) was cracked, eroded and/or poorly sealed. This is a common condition, but can lead to moisture penetration and subsequent damage. We recommend that it be resealed by a chimney specialist as a preventative measure.

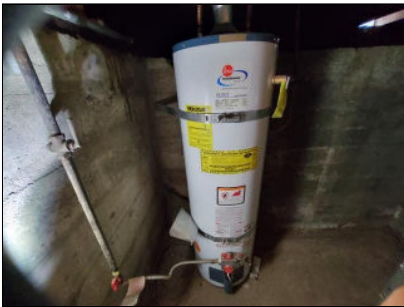
- ◆ The water heater was strapped or braced in the lower and upper third of the tank, however the straps do not encircle the tank before attaching to the wall. Although this is technically incorrect, it is our opinion that the bracing is adequate and secure. Modification to encircle the tank should be considered, however it could be performed as part of ongoing improvements.

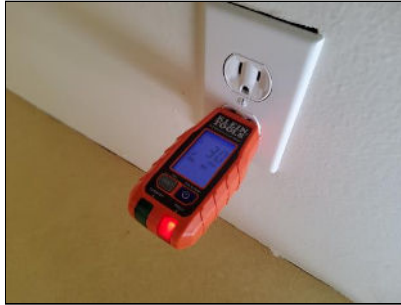
- ⏏ ◆ There were a minimum number of receptacles installed in portions of this building, and some of them are the ungrounded two prong type. Although this is typical in older buildings, we recommend that additional receptacles be considered, and that all of the receptacles be upgraded and grounded in the course of ongoing improvements.
- ✖ ◆ A receptacle in the kitchen on the right side of the sink was found to be wired incorrectly with an "open neutral" condition. The receptacle will not function properly with this configuration. We recommend repair by a qualified, licensed electrician.

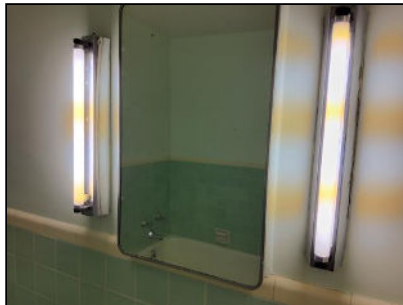
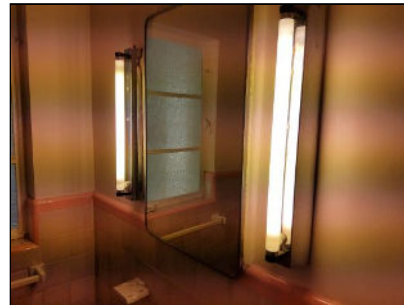
- ◆ NOTE: Although the living room did not include overhead lighting, switched receptacles were present. Current standards require that all rooms have either a switched overhead light, or a switched receptacle to ensure that a light can be turned on from an entry door.
- 📐 ◆ The lens covers were missing from the vanity light fixtures in the bathrooms. We recommend they be replaced to protect the bulbs from physical damage.

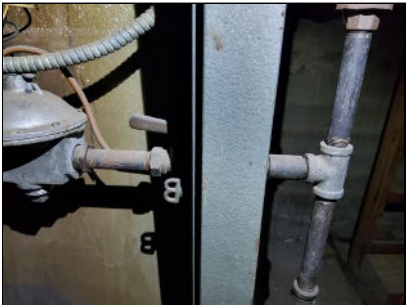
♦ The gas supply for the heater is rigid piping. We recommend the installation of a flexible supply connector as an upgrade to help limit damage in the event of a major earthquake.

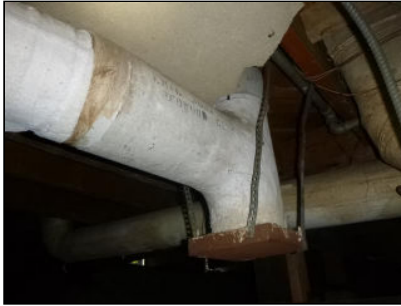
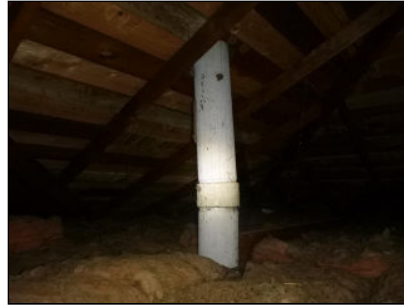
- ◆ The furnace and water heater vents terminate into a transite (asbestos cement) flue pipe, which is no longer approved. No particular deficiencies were observed, however reconfiguring or replacement should be considered and anticipated, particularly when the furnace is replaced. If more information is desired, we recommend referral with an asbestos abatement contractor.

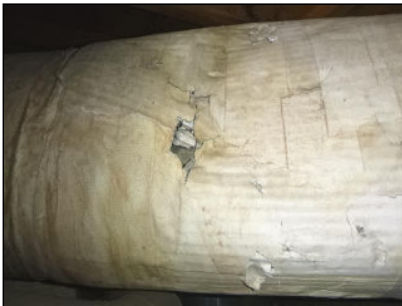
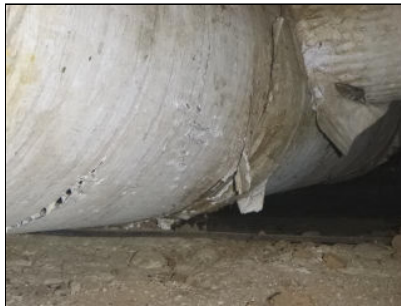
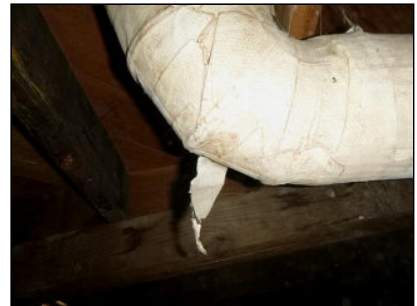
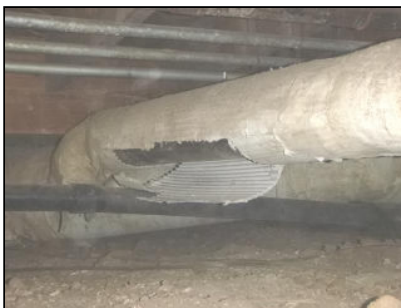
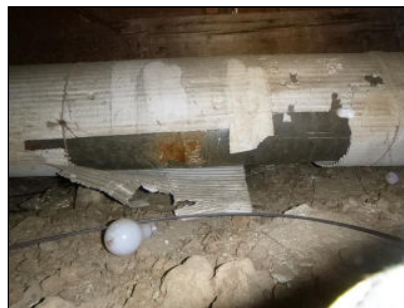
- ✘ 11. The heat ducts were insulated with a material that we suspect may contain asbestos. The material is loose, damaged and in overall poor condition. Identification and testing are beyond the scope of a home inspection. If more information is desired, we recommend referral with an asbestos abatement contractor.

- ◆ NOTE: The flow of air was checked at each of the accessible registers. The registers that were closed were not opened, and any registers that were blocked by furnishings or any other items were not checked. We did not attempt to measure the flow, and only observed that there was some flow of air from register to register. Exact measurement of air flow requires special equipment and is beyond the scope of our inspection. We recommend inquires of the seller regarding the adequacy, and comfort level in each of the rooms throughout the house at various times of the year.
- ✗ ◆ The heat ducts were insulated with a material that we suspect may contain asbestos. The material is loose, damaged and in overall poor condition. Identification and testing are beyond the scope of a home inspection. If more information is desired, we recommend referral with an asbestos abatement contractor.

- ◆ The furnace cold air return ducts were not insulated. We recommend that insulation be retrofitted for improved efficiency.
- ◆ There was no filter observed at the furnace or the cold air returns. We recommend that a filter(s) be installed to filter out dust, and to prolong the furnace service life.

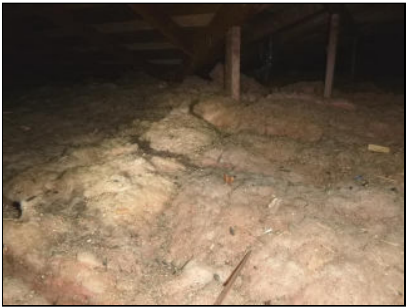
- ⬆ ◆ Insulation was observed in the attic space, however there was no insulation installed at the attic access hatch. We recommend installing foam board or batt insulation and weatherstripping at the access hatch for improved comfort and efficiency.

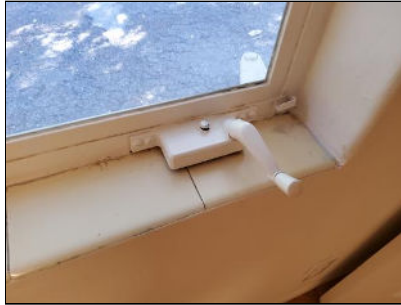
- ◆ A representative sample of windows were tested (not all windows were opened, closed, and latched). The sampled windows appear to be properly installed and in serviceable condition, however it is possible that windows that were not tested may require maintenance or repair.
- ◆ Some of the windows were stuck or have been painted shut. We recommend repair as necessary to restore proper function.
- ◆ The casement crank mechanism for one of the windows in the left rear bedroom was damaged, preventing the window from opening. We recommend repair or replacement as necessary by a qualified, licensed contractor or window specialist.

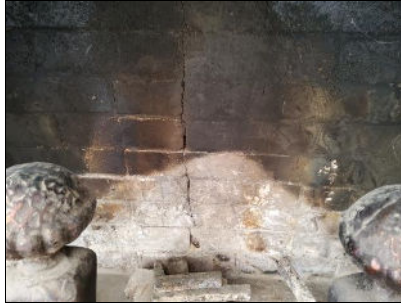
- ✦ The masonry firebox was showing wear and tear, including some soft, crumbly, or deteriorated mortar and/or bricks. The damage was not extensive, however we recommend further review by a chimney specialist, and maintenance or repairs performed as recommended.

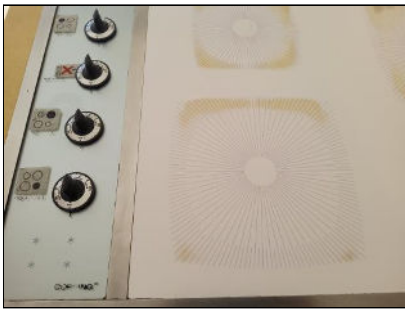
- ✘ 16. The left front cooktop burner was not functioning at the time of inspection. We recommend repair as necessary by a qualified appliance repair professional. Replacement of the cooktop may be necessary.

- ⚠ ◆ The left front cooktop burner was not functioning at the time of inspection. We recommend repair as necessary by a qualified appliance repair professional. Replacement of the cooktop may be necessary.

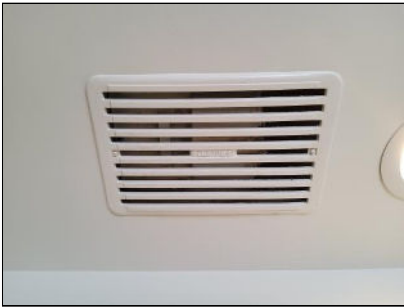
- ⚠ ◆ There was a kitchen exhaust fan installed, however the unit was not installed over the cooktop, did not feature a hood, the motor was dirty and loud when operated. We recommend replacement with a modern exhaust hood over the cooktop by a qualified, licensed contractor to meet current standards and for improved performance and indoor air quality.

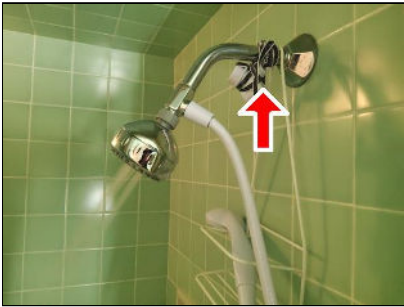
- ◆ There was no permanently installed mount for the shower head in the left side hall bathroom shower. We recommend replacement for improved function and convenience.

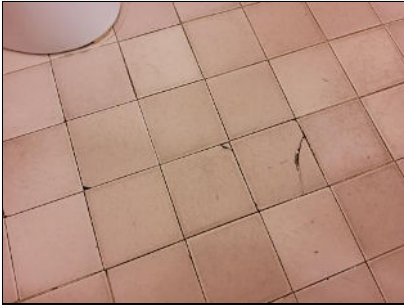
- ◆ Some of the floor tiles were cracked in the right side hall bathroom. The cracks appear to be primarily cosmetic, and repair or replacement is only recommended for a better appearance.

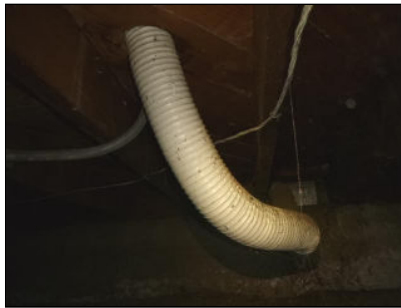
- ◆ NOTE: Clogged dryer lint ducts can adversely affect the operation of the dryer and can be a potential fire hazard. We recommend they be periodically cleaned to ensure safe and efficient operation of the dryer.
- ◆ We observed a flexible plastic dryer vent routed through the crawl space. Flex ducts are not permitted in crawlspaces and plastic ducts are not permitted for use with dryers. This should be considered a potential fire hazard. We recommend that the flexible vent be replaced with rigid venting in accordance with present standards. Typical requirements are a 4 inch smooth wall duct, no screws, no longer than 14 feet, with a hooded damper at the exterior. A flex duct (6 ft max.) may be used at the dryer connection but cannot go through floors, walls, crawl spaces or attics.
